SEISMIC VULNERABILITY ASSESSMENT OF EXISTING HOSPITAL BUILDINGS IN IMPHAL CITY

The present study deals with the seismic vulnerability assessment of an important existing Reinforced concrete building of public interest- a hospital- situated in Imphal city, Manipur. Imphal city lies in a longitude of 93°56'E and a latitude of 24°44'N, which is the capital of Manipur state in the North-east part in India. North-east India is one of the seismically active regions out of the most active regions in the world. This region falls under Zone-V of the earthquake Zonation map of India (zone of most severe seismic hazard) according to IS1893:2002. A field survey of some of the existing hospital buildings in Imphal was carried out and a preliminary assessment of seismic vulnerability was made. The Rapid Visual Screening (RVS) was done by using RVS form by Prof. Arya. One of the hospital buildings which were found to be vulnerable from RVS was evaluated using numerical analysis, using SAP2000 in order to assess their vulnerability for Simplified Vulnerability Assessment (SVA). The deficient members observed from the output are suggested for strengthening and retrofitting.

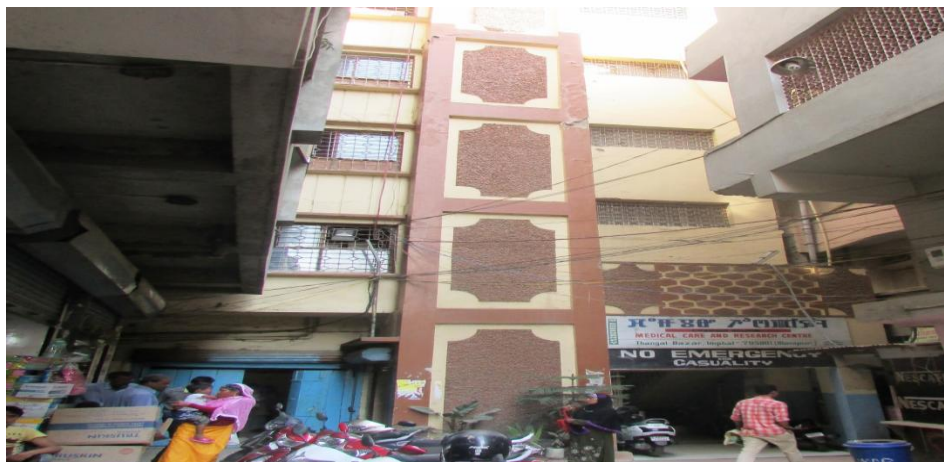
Fig1. Chamber Hospital

From the vulnerability assessment, Chamber Hospital falls under Grade 4 (G4) in which heavy structural damage and very non-structural damage occurs. G4 damage includes large cracks in structural elements with compression failure of concrete and fracture of rebar's; bond failure of beam reinforcing bars; tilting of columns.

Since, the results of Chamber Hospital falls under G4, it will experience severe structural damage from RVS analysis. Hence, further analysis i.e., SVA is carried out for the said building.

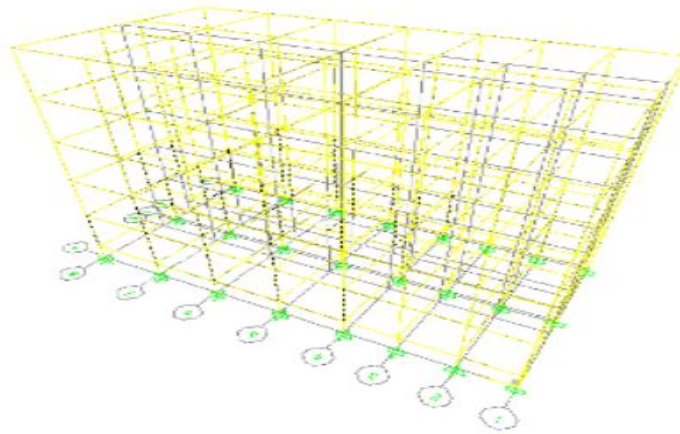
Analysis exposes some weakness in the building. The dotted line in the output of analysis shows structural failures of beams and columns. Some columns are built as floating columns. It shows that the columns and beams at the ground floor and the first floor fails; indicating excessive ductility demand in the ground and the first storey column, which may lead to collapse indicating unacceptable performance and need to be retrofitted. The output of the analysis in 3-D model is shown in fig. 4, fig.5 and fig.6 respectively.

Fig.4. 3-D model showing failed columns and beam of the structure.

The level-2 procedure (SVA) has been completed on the Chamber hospital building and the performance objectives have been imposed to satisfy the code compliance and to insist favourable failure pattern. Columns and beams in the ground floor and the first floor were found deficient. 30 numbers of column members and 5 numbers of beams were found deficient (overstressed). The cross-sectional area has been increased and reanalysed and some column members were found safe and few column and beams remain failed. Thus, the cross-sectional area has been increased and redesigned and found safe. The structures were redesigned, correcting the vertical irregularities by removing the floating columns and then the structure was found to be safe without any deficient in column and beam. Thus, retrofitting is not the best or suitable choice for this condition.

In our present study, Chamber hospital has been surveyed in the Level-1 procedure (i.e. RVS procedure). The building was found to be vulnerable and hence require level-2 procedure. In the Level-2 procedure, the chamber building was evaluated by Numerical Analysis using SAP 2000. Considering the thirteen-load combinations as per IS 1893:2002, the hospital building was found to be deficient in 30 columns and 5 beams out of the total members. In older RC hospital building, column failures were more frequent since the strength of beams in such construction was kept higher than that of the column. Thus, increasing the cross-sectional area and enlarging the member sizes with the concept of strong column-weak beam, the building was not found to be safe. The building was recommended for retrofitting through column jacketing and beam jacketing. However, after redesigning by removing the floating column of the structure, the building was analysed further and was found to be safe. The retrofitting was not needed after this later analysis. Hence, from the view of the analysis, redesigning the hospital building is the most suitable recommendation to prevent from seismic hazard.
