A Research Paper on Performance of Jia Bharali River

Bank Protection Measure using Geotextile Bags

Mayank Kumar Gupta

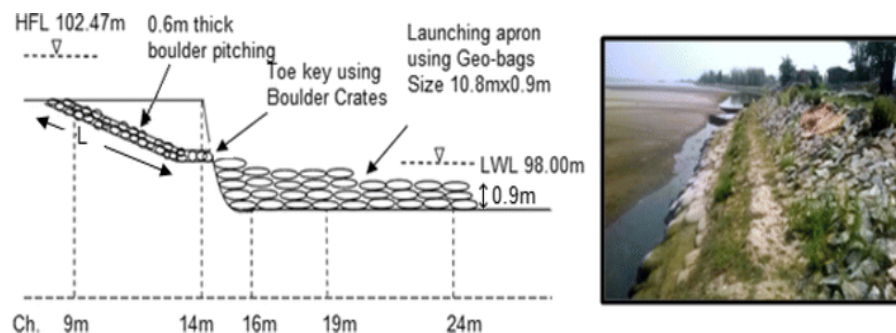
Figure 3

The detail of the protection work designed and installed at the river bank by the Water Resources Department (WRD) is shown in Fig. 3 and Table 2.

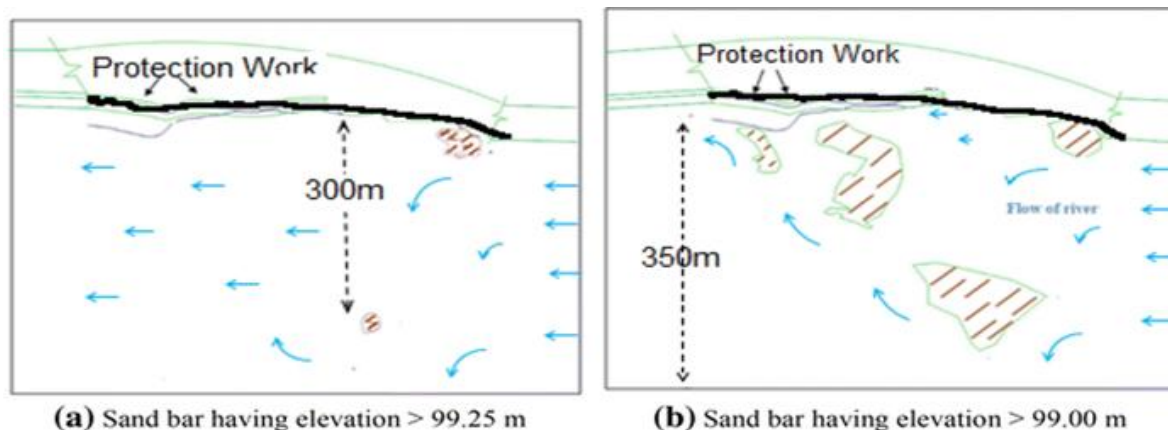
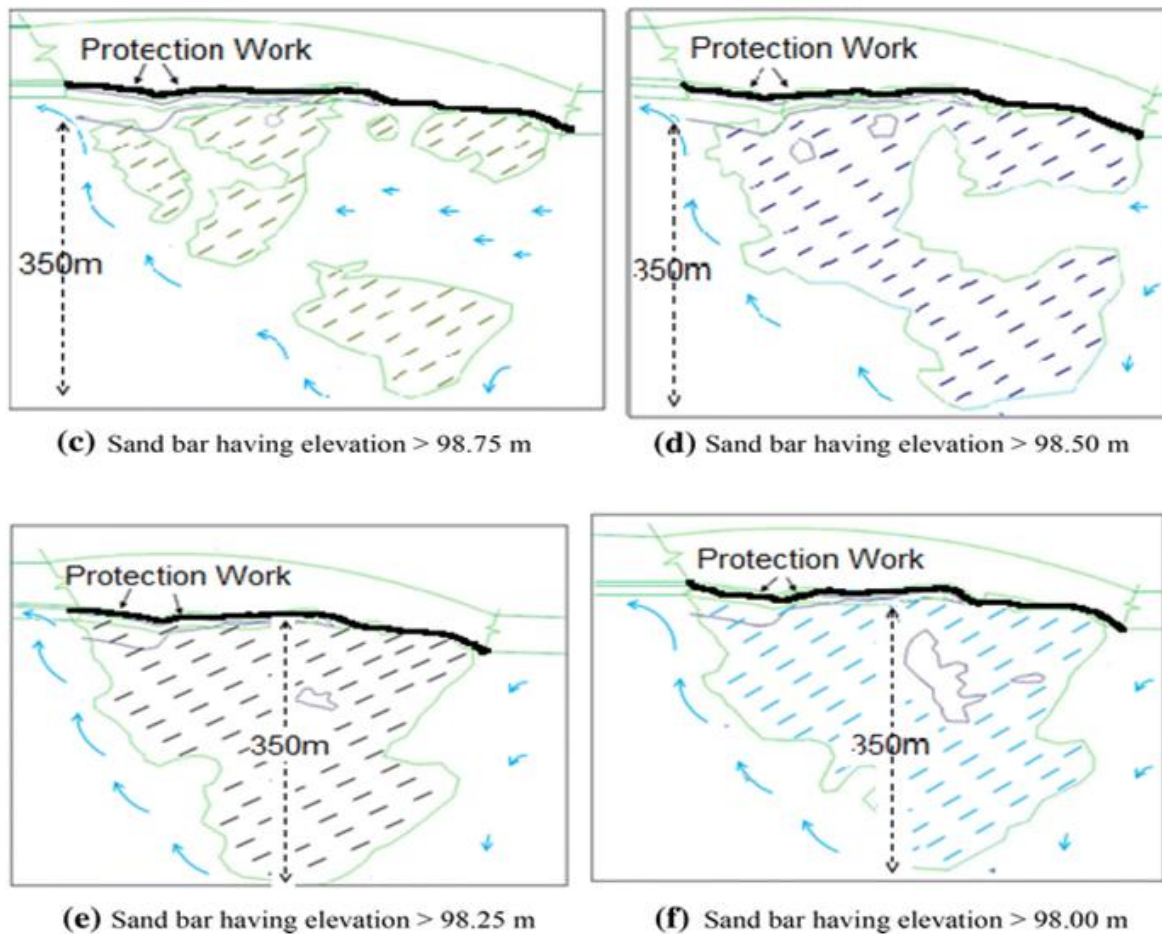
Fig. 5 Sand bar having
elevation a >99.25 m; b >99.00 m; c >98.75 m; d >98.50 m; e >98.25 m; f >98.00 m

As the speed of stream is diminished after establishment of the bed cook's garment the primary indication of siltation is seen close to the upstream end of the bed smock (Fig. 5a). Figure 5a likewise demonstrates start of

mid-channel siltation at an area around 300 m far from the bank showing redirection of the waterway stream bearing far from the insurance work. As the surge water retreats the siltation territory develops around the underlying mid-channel sand bar and furthermore close to the downstream side of the starting smock (Fig. 5b-d). It demonstrates progressive redirection of the waterway water stream channel far from the bank. Figure 5 demonstrates that the zone of impact of the bed assurance work through propelling overskirt stretches out up to remove 350 m from the bank into the stream which is about 30 times that of the 10.5 m width of the starting cover.

Figure 5e, f demonstrates that in spite of the fact that the starting smock effectively redirected the stream water stream channel far from the bank close to the upstream end of the insurance measure and brought about advancement of another sand bars no siltation happens quickly past the downstream end of the assurance measure and the waterway channel returns strongly towards the bank just past the downstream end of the bed cook's garment. Since the bank soil is erodible, as obvious from the geotechnical testing, this sharp stream of the waterway towards the bank downstream of the security work has made it profoundly powerless against impinging stream disintegration.

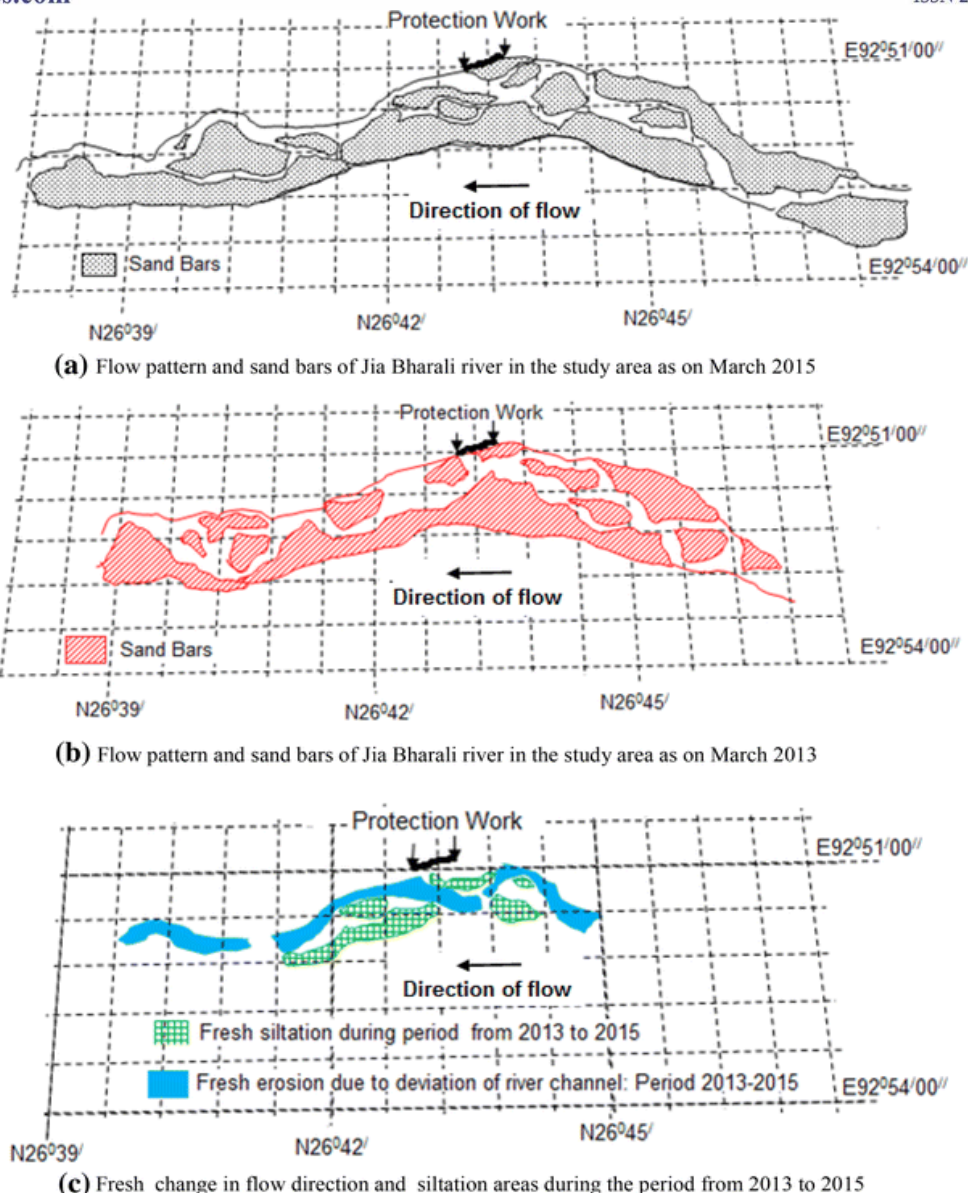
Fig. 6

Flow pattern and sand bars of Jia Bharali river **a** in the study area as on March 2015; **b** in the study area as on March 2013. **c** Fresh change in flow direction and siltation areas during the period from 2013 to 2015.

Figure 6 plainly demonstrates that the waterway channel has strongly returned into the bank. This channel has begun new bank disintegration in the prompt downstream of the insurance work.

Jia Bharali stream, after establishment of the assurance measure in the western bank, has logically come nearer to a similar bank in the downstream of the security work. It, consequently, has additionally expanded the powerlessness of the bank to disintegration in quick downstream of the security measure. In this downstream segment of the stream, amid the time of 2 years from 2013 to 2015, the waterway has changed course towards the western bank bringing about bank disintegration and arrangement of mid-channel sand bars. This has made an earnest need to ensure the waterway bank facilitate downstream of the assurance work under review.

From this review it is presumed that short length bank security measures with bed overskirt utilizing geotextile packs, albeit viable in ensuring a planned zone, has the capability of driving the disintegration issue towards the downstream zone of a similar bank. Such venture arranging needs to incorporate measures to lessen downstream bank disintegration especially if the geotechnical properties of the bank soil in the downstream extend are observed to be poor.
