STUDY ON FAILURE OF HIGH EMBANKMENT IN ROAD WORK ON MARSHY AREA AND RECTIFICATION WORKS BY IMPLEMENTATION OF GROUND IMPROVEMENT TECHNIQUES SPECIFIC TO THE GROUND CONDITION

Nishanth.B.S¹, Arun Prabha², Chethan Kumar N T³

¹ Sr. Manager, Mangalore SEZ Limited, Mangaluru, Karnataka (INDIA) ²Sr.Professional Engineer (ECI), Principal Consultant, Projectile, Mangaluru, Karnataka (INDIA) ³Assistant Professor, Civil Engineering Department, SCEM, Mangaluru, Karnataka(INDIA)

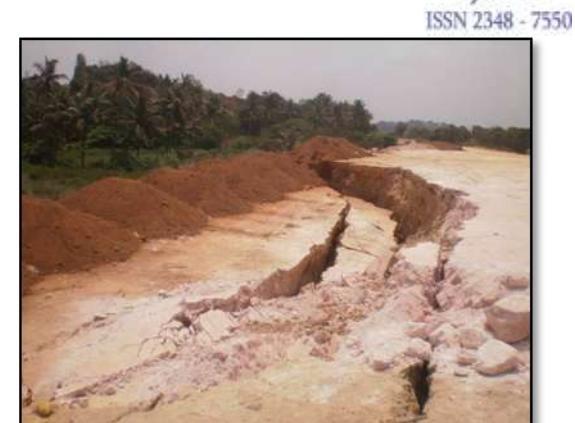
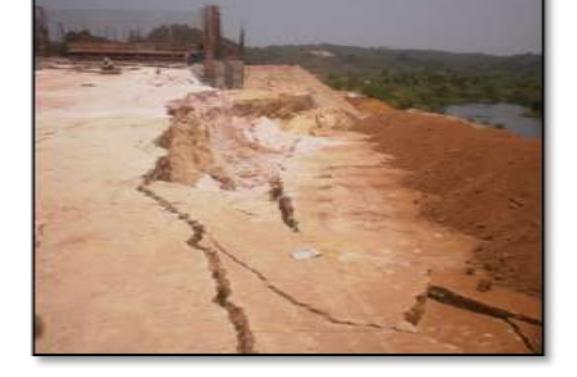
This project study pertains to development of a 2-lane road from Kana Junction in Surathkal area to Jokatte. It is reported that the embankment was sinking and remedial measures need to be undertaken to address the issue. The road being built is traversing through marshy land near Jharandaya temple in Thokur and thereafter on western side of Konkan Railway till Jokatte. This marshy land is caused due to the backwater of Gurpur river which exhibit heavy salt content due to the presence of the Arabian sea in the vicinity. While constructing the earthen embankment, the soil in about 75 m stretch on one side of the road has sunk to an extent of 3 m and some cracks are also seen on balance portion of this stretch. Since the cost of embankment by reinforcing the ground conditions or construction of bridge in marshy area was uneconomical, the constructed embankment was re-laid by spreading and compacting the existing embankment soil and then increasing the width of embankment base by additional 30-50m and construct the embankment by doing proper compaction layer by layer and providing horizontal berm with extra earth to prevent sliding on the edges. However the embankment failed due to development of shear cracks being developed in spite of additional width of the base width of the embankment formation.

Embankment snapshot and photos after embankment failure after initial construction activity

Site Photo of Embankment failure for Normal Embankment toe width

It is suggested to remove the entire embankment soil for this stretch and do the ground improvement of the foundation soil by stone columns and drainage layer and layer separation by using geo-synthetics.

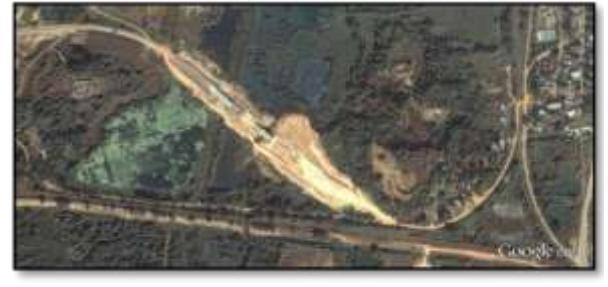
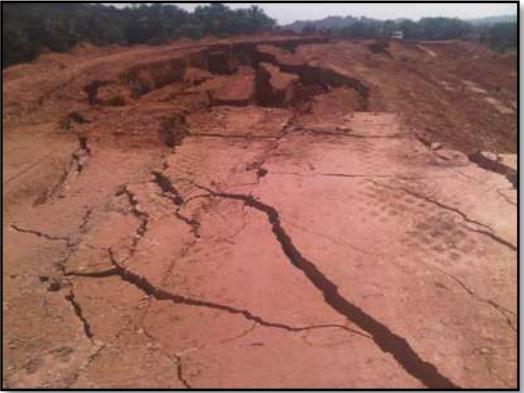
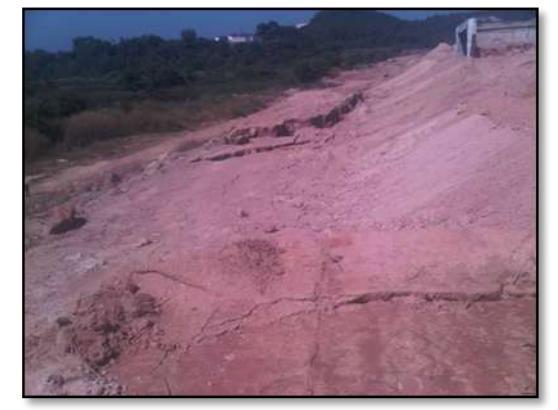
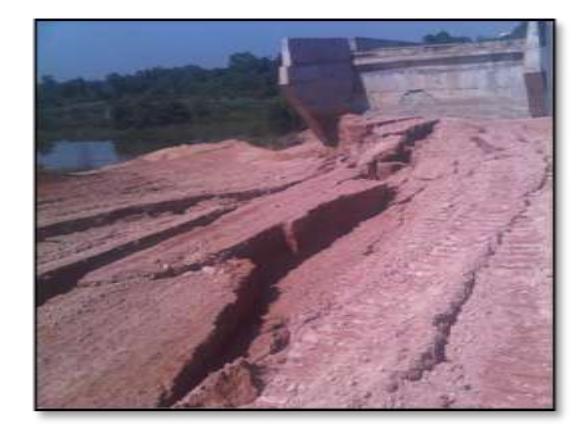
Snapshot after embankment failure after additional widening of the base

Site Photo of Embankment failure (Sliding & Shear) for Additional Embankment toe width

The bore log near the approach area (**BH1**), indicate very low 'N' values (observed blow counts from SPT test) up to almost 10 m depth. This low blow Count values indicate that the soil at top 10m is very weak (meaning very very low bearing capabilities and high compressibility's), soft and under-consolidated; and water table indicated is also high (1 m below the existing ground level). The soils are identified as fine grained soils, clayey/silty. The height of embankment constructed is 10 to 11 m, with side slopes of 1.5H:1V. This imposes a load on the weak foundation soil in excess of 200 kN/m2 which the weak foundation soil cannot sustain. This is reflected as a bearing capacity (shear) failure as seen from the large settlements of nearly 3 metre beneath the embankment, and also very significant ground heave at the toe.
