CHALLENGES OF SEDIMENTARY HAZARDS EMERGENCY RESCUE OPERATIONS UNDER EXTREME RAINFALL CONDITIONS IN MOUNTAINOUS AREAS IN TAIWAN

C. Y. Chen¹, T. C. Chen²

¹Professor, Department of Civil and Water Resources Engineering,

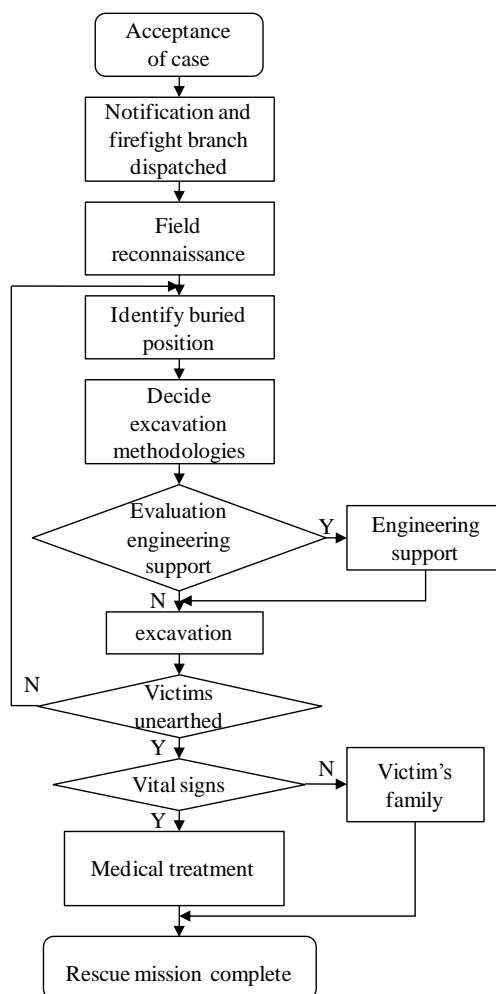
Fig. 1: Flowchart of Emergency Rescue Operation Procedure for Sedimentary Hazards (revised after Chiayi County Fire Bureau, <http://w3.cycfd.gov.tw/>)

In Taiwan, the procedure for sedimentary hazard emergency rescue operations is carried out by local fire departments (Fig. 1). It includes:

1. Confirm the magnitude of sedimentary hazard and request support needed. Sedimentary hazards could be rockfalls, slips, landslides, debris flows, and riverbank erosion. Query eyewitnesses to learn how many people are buried by debris mass and their possible locations. Supporting units may include:

2. Identification of possible locations of debris masses and buried people. The most direct method is by querying eyewitnesses or persons in the area. It is possible to survey locations of victims using field topography and scientific instruments.

3. Determine how to excavate. Excavation work by manual labor is required at the beginning to prevent heavy machinery from doing further injury to victims. Consent of the victim's family is necessary to permit use of heavy machinery to excavate after 72 hours have passed without manual labor resulting in rescue. Engineering support is required to prevent further collapse of debris masses. Excavation from the top of collapsed buildings downward is prohibited to prevent further hazard. The field commander is responsible for deciding on the type of excavation and for determining whether to re-survey to find the possible location of victims.

4. Emergency medical treatment: Victims will be returned to the family if they do not display vital signs. If the victims have vital signs or the family demands resuscitation attempts, the victim will be immediately taken to the hospital. The rescue action is finished at this stage.

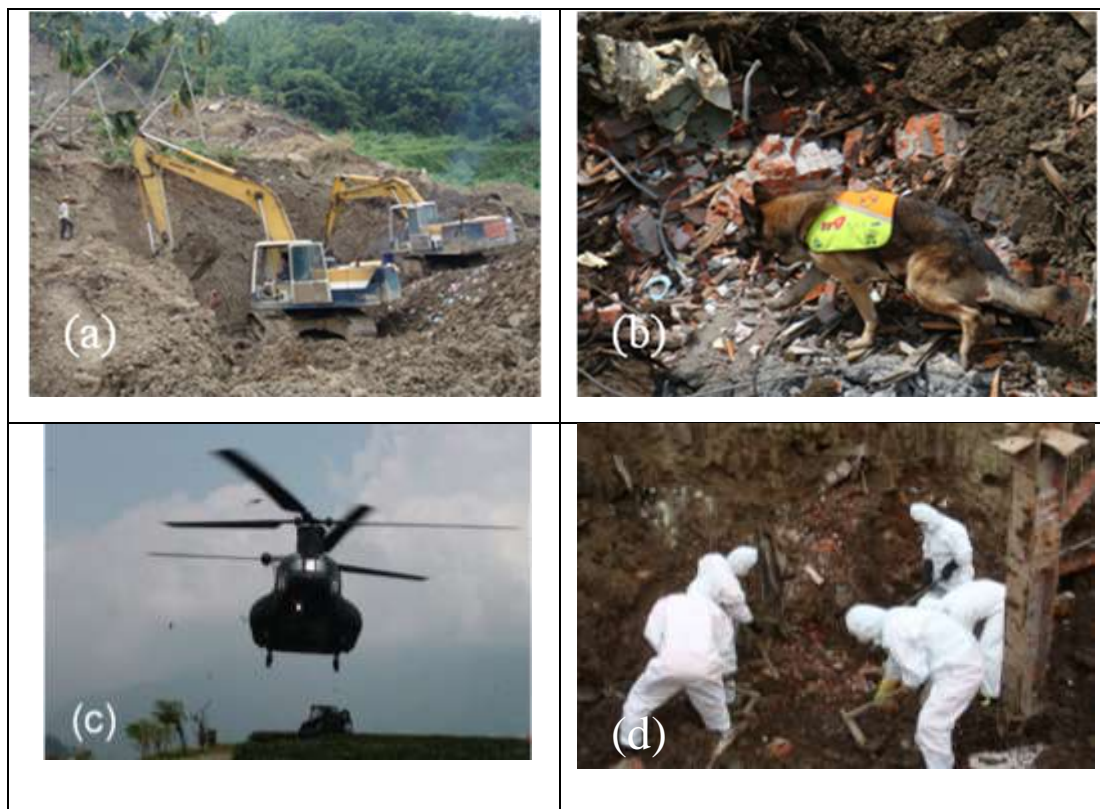
Fig. 3: Sedimentary Hazards Emergency Rescue in the Taihe Village (a) Excavators Removing Debris (b) A Sniffer Dog Searching for Buried Victims (c) A Shovel Loader was Hanged by the Helicopter for Blocked Road to Rush Through Urgently (d) Relief Workers Excavate Debris Masses using Hand Tools (August of 2009, Chiayi Fire Bureau, Chiayi County)

The severe weather also stopped helicopters bringing food and other necessities to the hazard scenes until 10 August, when three firefighters took a plane to the village. A shovel loader was hanged by the helicopter for road to rush through urgently. A rough emergency road finally enabled a team of seven firefighters, one sniffer dog and two trainees, 30 soldiers and two big excavators, to reach the area on the 26th. The excavation started in the morning of the 26th and by the following afternoon the bodies of the four victims were unearthed (Fig. 3).

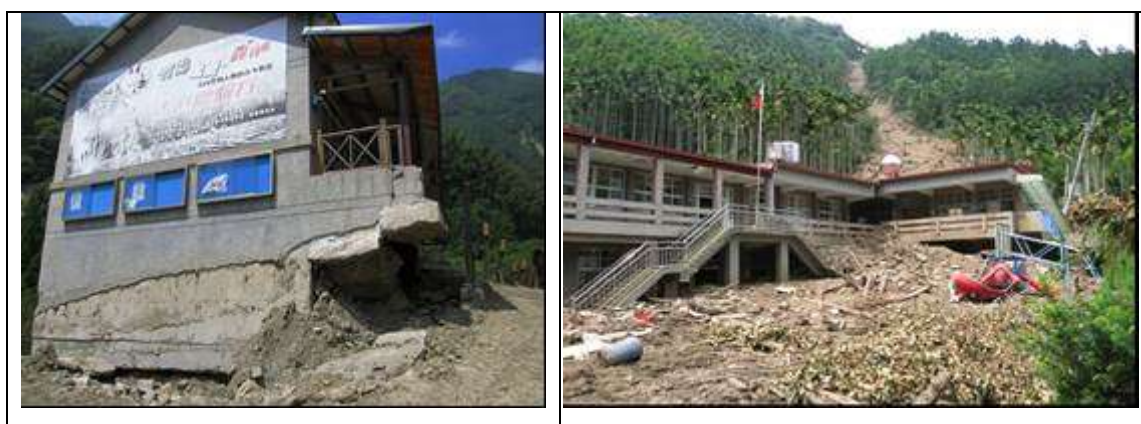
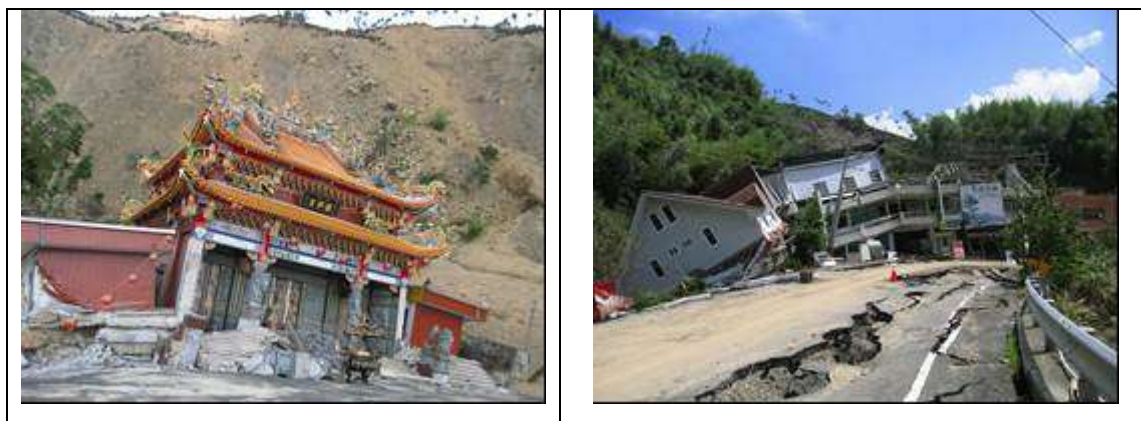
Fig. 4: Damages of the Four Temporary Shelters in the Taihe Village

The rescue action lasted 20 days, from 9-28 August, 2009. The Chiayi County Fire Bureau sent 223 person, 40 vehicles, and support organizations assisted with a further 189 person, 65 vehicles (Chen and Chen, 2011). In addition, there were four evacuation shelters and six public buildings available for temporary shelters in the village. Most of the shelters were damaged or cutoff by landslides (Fig. 4).
