# STUDY ON FAILURE OF HIGH EMBANKMENT IN ROAD WORK ON MARSHY AREA AND RECTIFICATION WORKS BY IMPLEMENTATION OF GROUND IMPROVEMENT TECHNIQUES SPECIFIC TO THE GROUND CONDITION

### **Embankment snapshot and photos after embankment failure after initial construction activity**

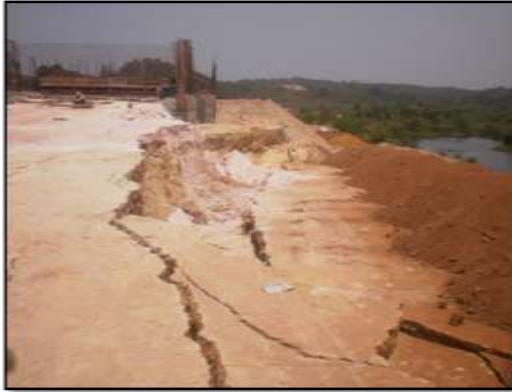
**Site Photo of Embankment failure for Normal Embankment toe width**

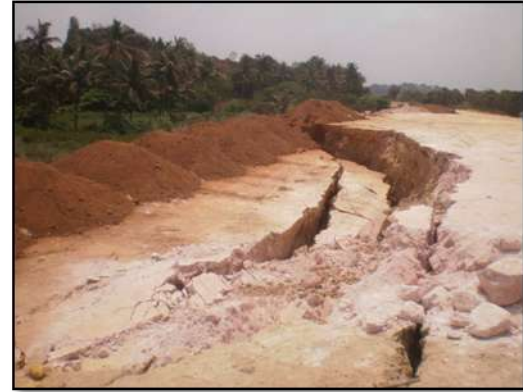
Snapshot after embankment failure after additional widening of the base

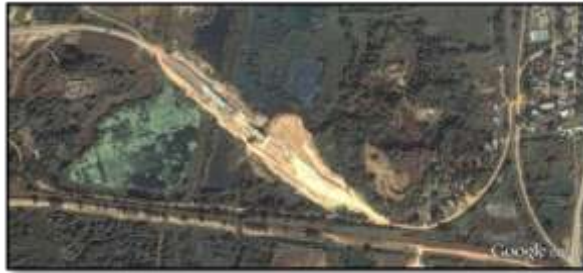
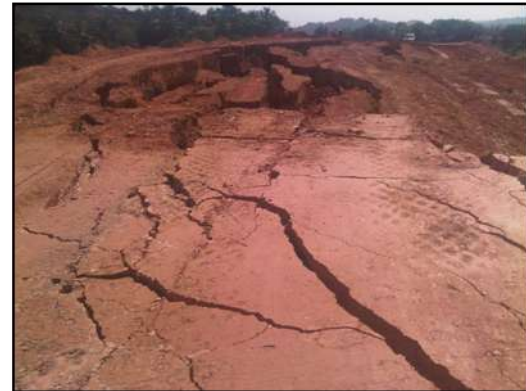
Site Photo of Embankment failure for Additional Embankment toe width

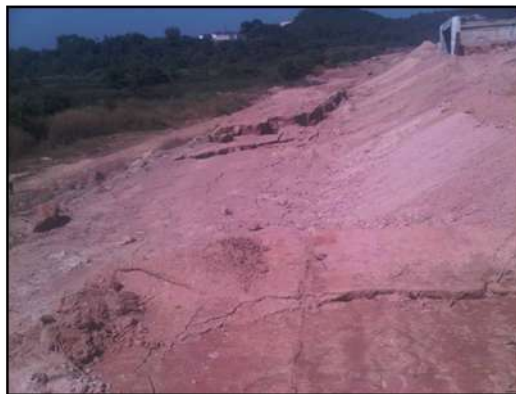
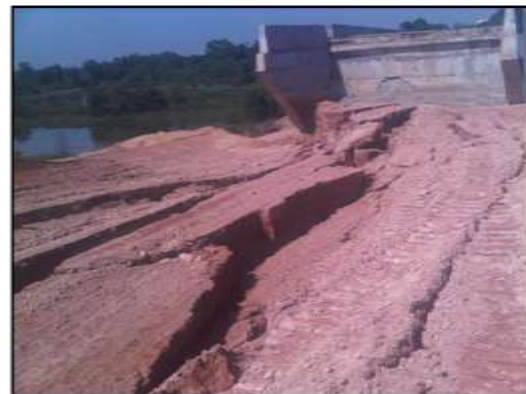
Site Photo of Embankment failure (Sliding & Shear) for Additional Embankment toe width

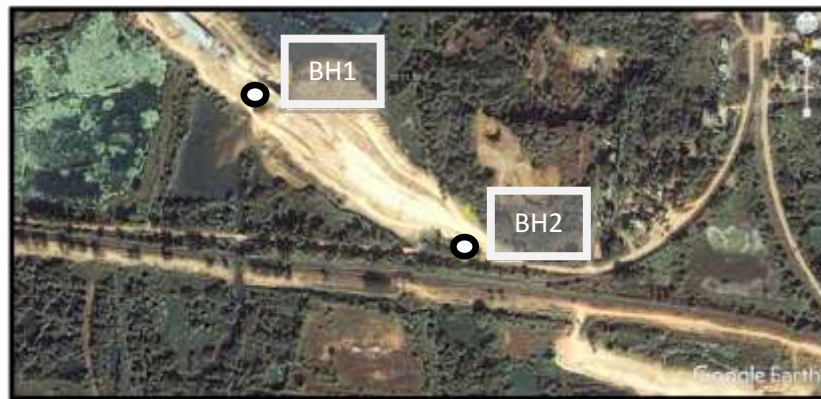
Fig 4.1 Borehole Location Map

The Borehole location is as follows:

**BH1 - 12°57'50.28"N 74°50'11.86"E (NEAR BRIDGE)**

**BH2 - 12°57'45.96"N 74°50'17.84"E (NEAR RAILWAY TRACK EMBANKMENT)**

The bore log near the approach area (BH1), indicate very low 'N' values (observed blow counts from SPT test) up to almost 10 m depth. This low blow Count values indicate that the soil at top 10m is very weak (meaning very very low bearing capabilities and high compressibility's), soft and under-consolidated; and water table indicated is also high (1 m below the existing ground level). The soils are identified as fine grained soils, clayey/silty. The height of embankment constructed is 10 to 11 m, with side slopes of 1.5H:1V. This imposes a load on the weak foundation soil in excess of 200 kN/m<sup>2</sup> which the weak foundation soil cannot sustain. This is reflected as a bearing capacity (shear) failure as seen from the large settlements of nearly 3 metre beneath the embankment, and also very significant ground heave at the toe.

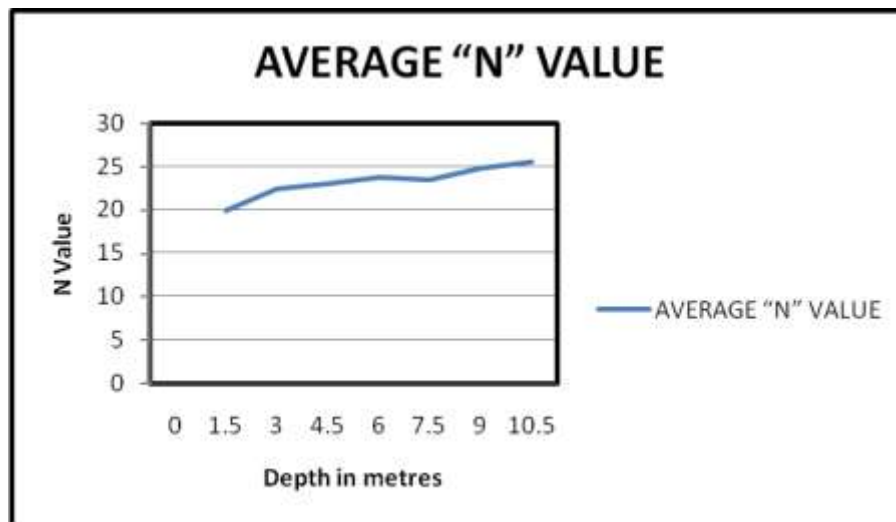
**Fig 5.1 Average “N” value Chart for depth of filling**

The N Value average across 20 boreholes indicate a compacted soil packing with a range of 40-60 % in relative density and friction angle ranging from 35 -40° .

As detailed in Table 5.1 pertaining to relation between SPT-N value, Friction angle and Relative Density the following inference is made based on the average N value.
