STUDY ON FAILURE OF HIGH EMBANKMENT IN ROAD WORK ON MARSHY AREA AND RECTIFICATION WORKS BY IMPLEMENTATION OF GROUND IMPROVEMENT TECHNIQUES SPECIFIC TO THE GROUND CONDITION

Nishanth.B.S¹, Arun Prabha², Chethan Kumar N T³

¹ Sr. Manager, Mangalore SEZ Limited, Mangaluru, Karnataka (INDIA) ²Sr.Professional Engineer (ECI), Principal Consultant, Projectile, Mangaluru, Karnataka (INDIA) ³Assistant Professor, Civil Engineering Department, SCEM, Mangaluru, Karnataka(INDIA)

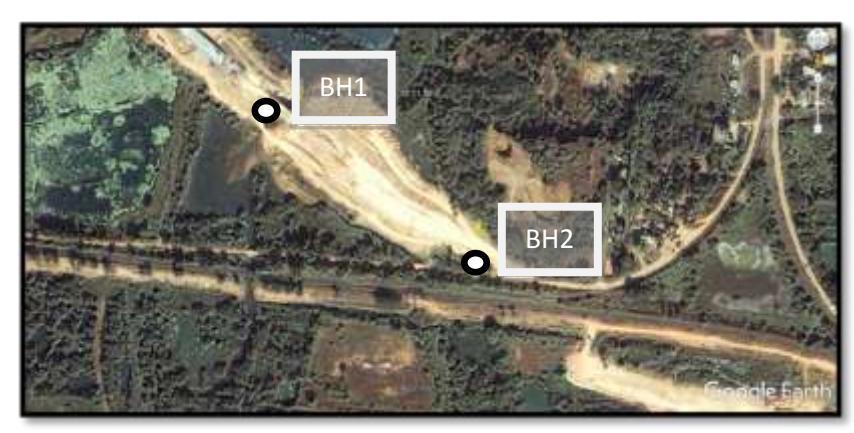
Fig 4.1 Borehole Location Map

The bore log near the approach area (**BH1**), indicate very low 'N' values (observed blow counts from SPT test) up to almost 10 m depth. This low blow Count values indicate that the soil at top 10m is very weak (meaning very very low bearing capabilities and high compressibility's), soft and under-consolidated; and water table indicated is also high (1 m below the existing ground level). The soils are identified as fine grained soils, clayey/silty. The height of embankment constructed is 10 to 11 m, with side slopes of 1.5H:1V. This imposes a load on the weak foundation soil in excess of 200 kN/m2 which the weak foundation soil cannot sustain. This is reflected as a bearing capacity (shear) failure as seen from the large settlements of nearly 3 metre beneath the embankment, and also very significant ground heave at the toe.

It is suggested to remove the entire embankment soil for this stretch and do the ground improvement of the foundation soil by stone columns and drainage layer and layer separation by using geo-synthetics.

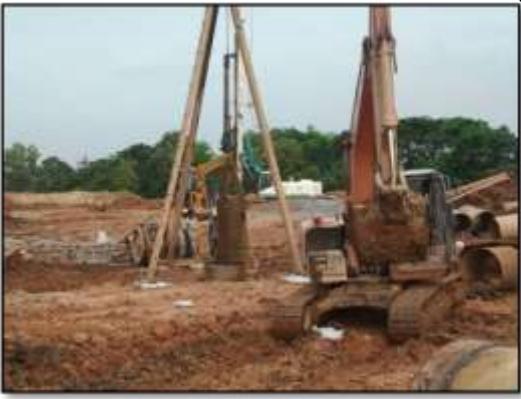
v) Providing & filling bored pile with granite metal of varying size from 40 mm downsize with top feed system using backhoe loader.

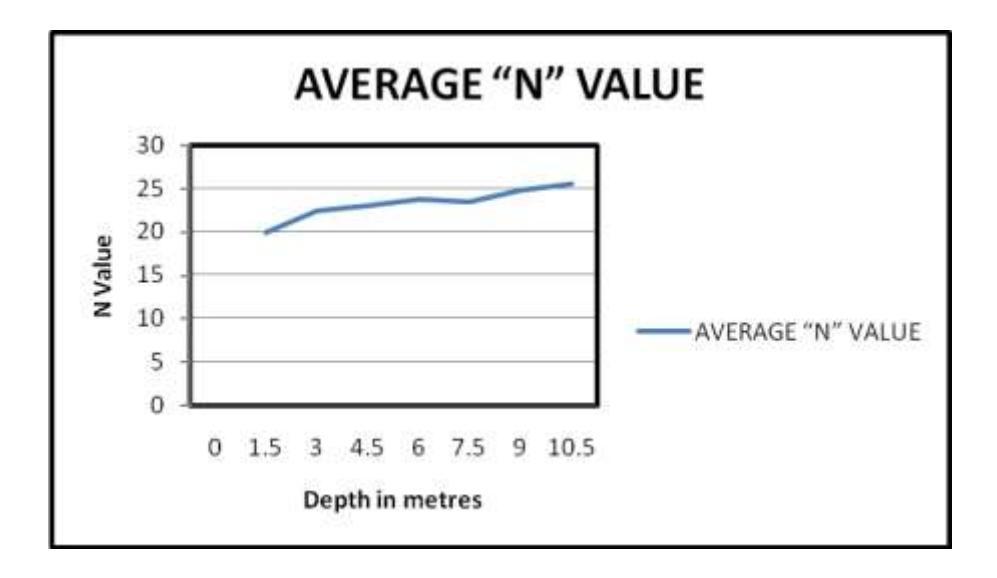
Fig 5.1 Average "N" value Chart for depth of filling

As detailed in Table 5.1 pertaining to relation between SPT-N value, Friction angle and Relative Density the following inference is made based on the average N value.
