SEISMIC VULNERABILITY ASSESSMENT OF EXISTING HOSPITAL BUILDINGS IN IMPHAL CITY

The present study deals with the seismic vulnerability assessment of an important existing Reinforced concrete building of public interest- a hospital- situated in Imphal city, Manipur. Imphal city lies in a longitude of 93°56'E and a latitude of 24°44'N, which is the capital of Manipur state in the North-east part in India. North-east India is one of the seismically active regions out of the most active regions in the world. This region falls under Zone-V of the earthquake Zonation map of India (zone of most severe seismic hazard) according to IS1893:2002. A field survey of some of the existing hospital buildings in Imphal was carried out and a preliminary assessment of seismic vulnerability was made. The Rapid Visual Screening (RVS) was done by using RVS form by Prof. Arya. One of the hospital buildings which were found to be vulnerable from RVS was evaluated using numerical analysis, using SAP2000 in order to assess their vulnerability for Simplified Vulnerability Assessment (SVA). The deficient members observed from the output are suggested for strengthening and retrofitting.

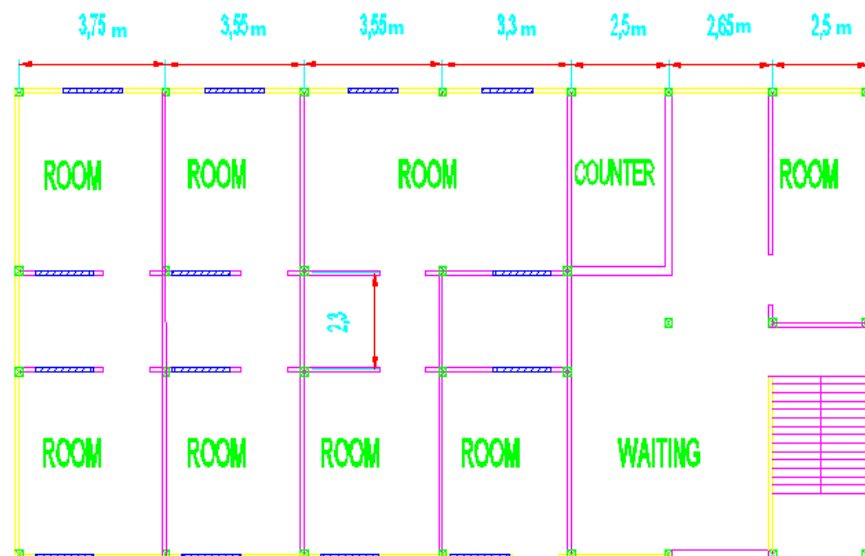
Fig.2. Plan of the Building

The base of the Chamber Hospital building has horizontal dimension of 11.0 m x 21.8 m. It has two bays along X-axis and seven bays along Y-axis in the ground floor. In the remaining four floors, it has three bays along X-axis and seven bays along Y-axis. The height of each room is 3.2 m. Height of the building is 16.0 m. The Material properties are assumed to be M20 Grade concrete and Fe 415 steel for the yield strength of the longitudinal and shear reinforcement. The details of the plan and elevation of the building are shown in fig.2 and fig.3 respectively. The sectional properties of various elements obtained are based on gravity analysis and use as initial sizes for further analysis, presented in Table 1.

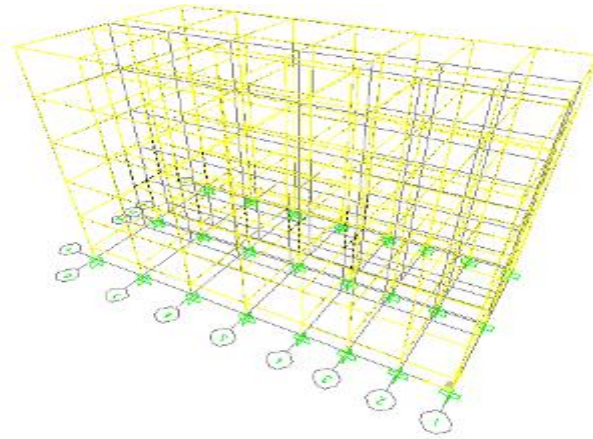
Fig. 5.3-D model of the structure after retrofitting

Analysis exposes some weakness in the building. The dotted line in the output of analysis shows structural failures of beams and columns. Some columns are built as floating columns. It shows that the columns and beams at the ground floor and the first floor fails; indicating excessive ductility demand in the ground and the first storey column, which may lead to collapse indicating unacceptable performance and need to be retrofitted. The output of the analysis in 3-D model is shown in fig. 4, fig.5 and fig.6 respectively.

The level-2 procedure (SVA) has been completed on the Chamber hospital building and the performance objectives have been imposed to satisfy the code compliance and to insist favourable failure pattern. Columns and beams in the ground floor and the first floor were found deficient. 30 numbers of column members and 5 numbers of beams were found deficient (overstressed). The cross-sectional area has been increased and reanalysed and some column members were found safe and few column and beams remain failed. Thus, the cross-sectional area has been increased and redesigned and found safe. The structures were redesigned, correcting the vertical irregularities by removing the floating columns and then the structure was found to be safe without any deficient in column and beam. Thus, retrofitting is not the best or suitable choice for this condition.
