A Research Paper on Performance of Jia Bharali River

Bank Protection Measure using Geotextile Bags

Mayank Kumar Gupta

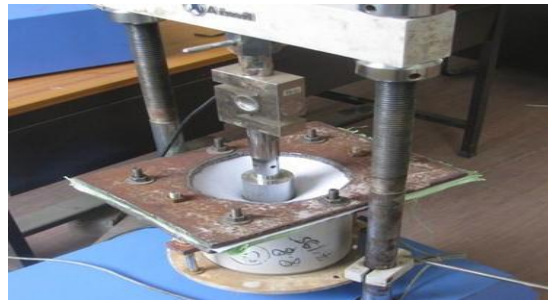
Figure 4 CBR Tssting

The geotextile material used in the project is of nonwoven type. A general inspection of the used and unused samples of the geotextile showed that the geotextile, after 3 years of exposure to field condition, has not shown any significant deterioration. The laboratory test results are shown in Table 3.

The results show that the nonwoven geotextile bag material used in this work, even after 3 years of field exposure, has not shown signs physical deterioration with only 15 % drop in its strength.
